Deacon Ridge Shower Valve Replacement

Given that our condos are 20+ years old and that nothing lasts forever, the shower valve cartridge assembly in the bathrooms will leak or become hard to operate. The information that follows covers how to replace the shower valve assembly(s).

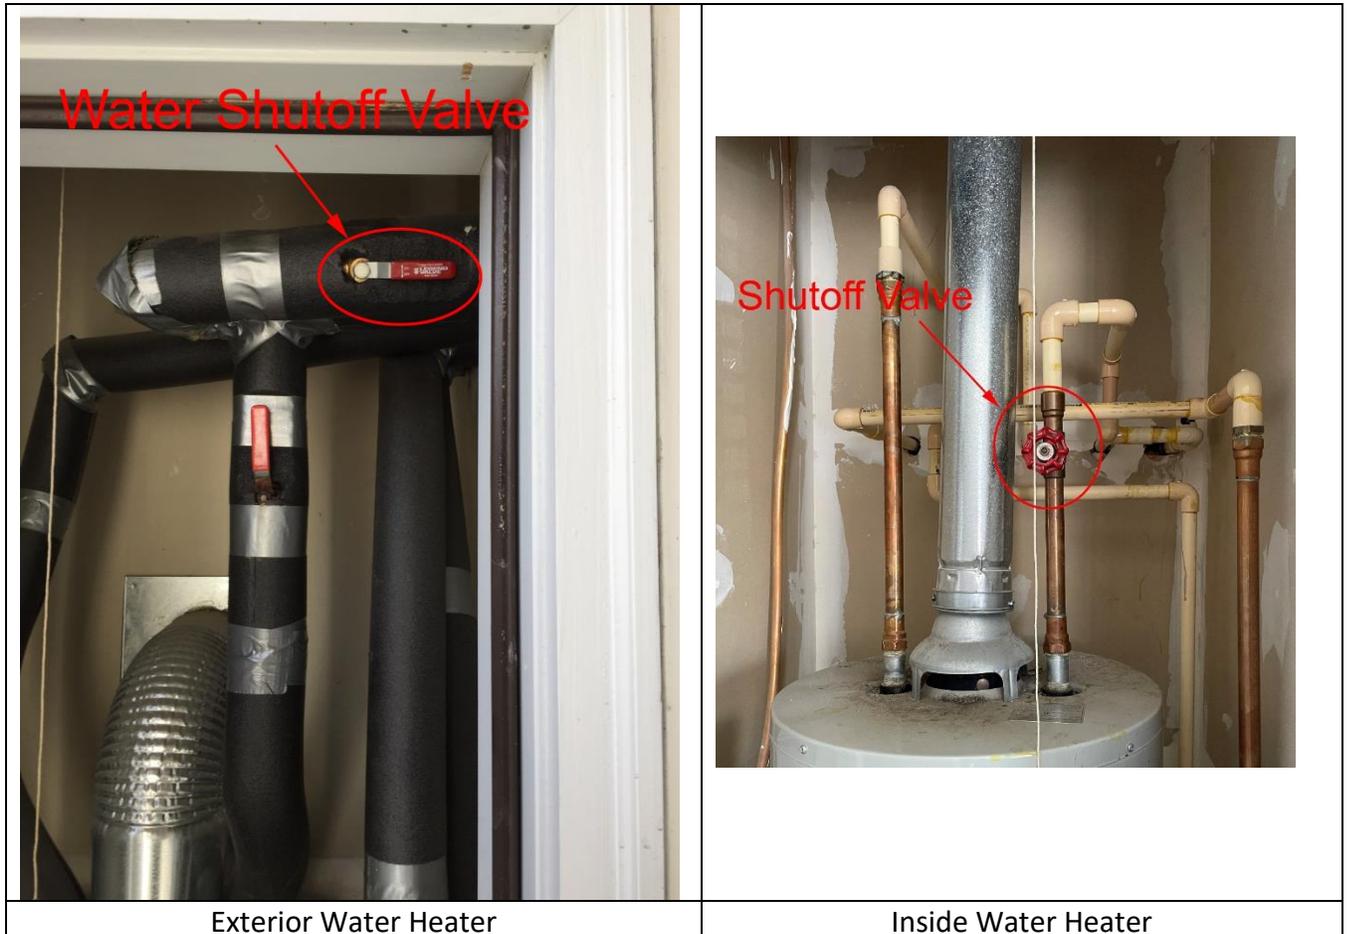
The shutoff valve is located above the hot water heater as shown above.

For Exterior Water Heaters: To shut off the water, rotate the red handle 90° so that it is horizontal. (The red handle will have arrows indicating the open and closed positions.)

For Interior Water Heaters: Rotate the red handle on the valve clockwise (to the right) until it stops.

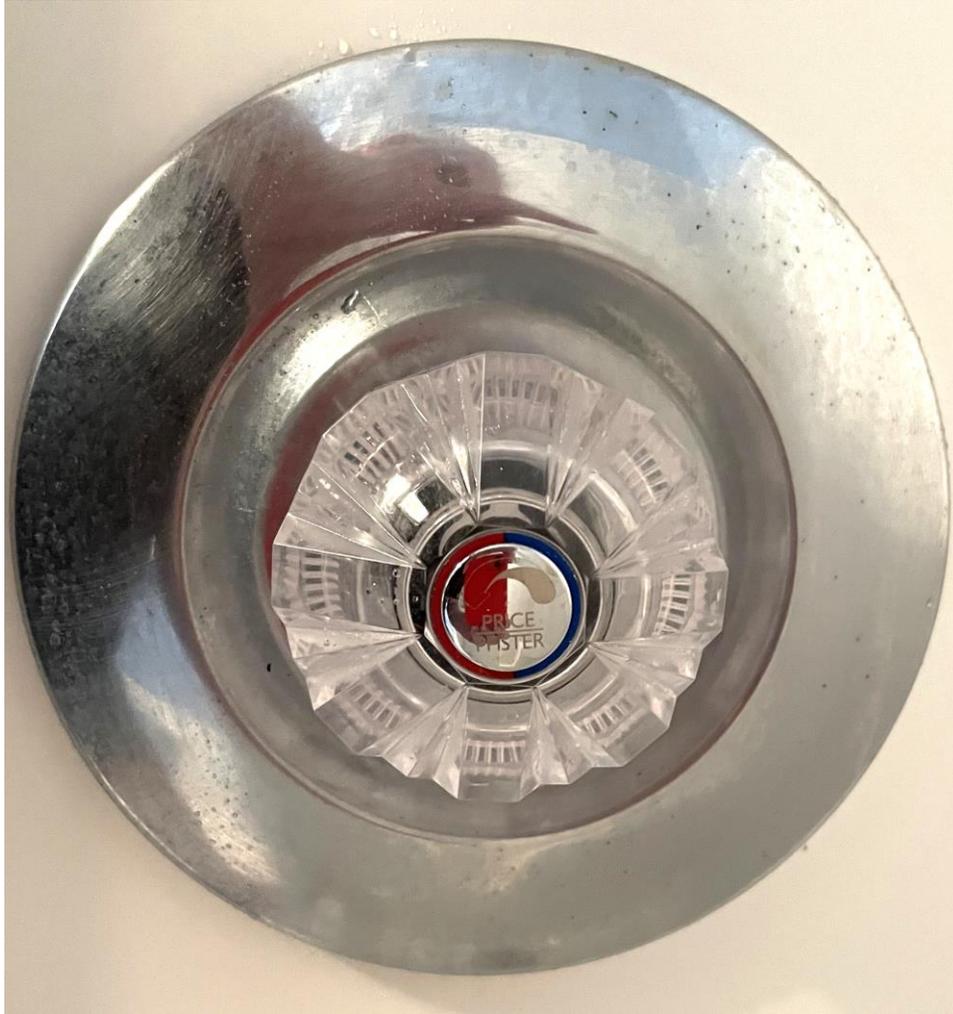
The shower valve is shown below. If you look closely you will see "Price Pfister" on the center cap.

The center cap can be removed with a finger nail. Under this cap is a Phillips head screw which must be removed in order to take off the shower handle.

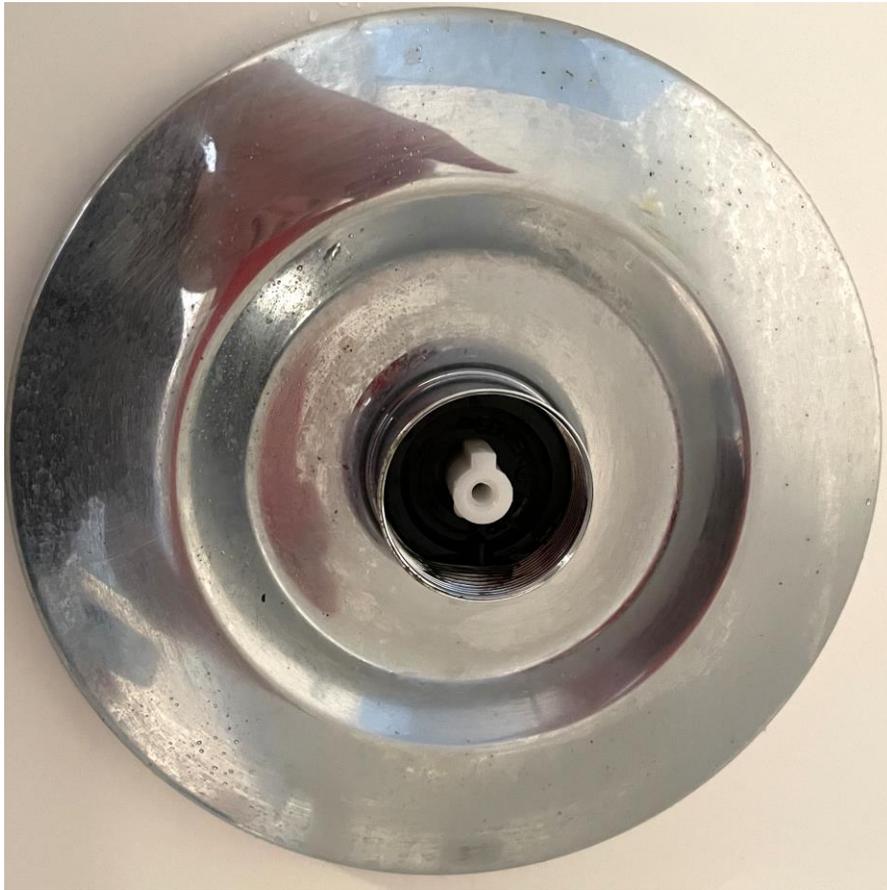
Faceplate and Collar

Once the handle is removed you will see the valve cartridge, a threaded collar and the faceplate. Remember the orientation of the center post – the protrusion will be pointing **UP!**

The threaded collar must be removed first by turning it counterclockwise. It may be stuck, but **DO NOT** use pliers or wrenches to turn it. **(If you use wrenches, etc., you run the risk of deforming the collar and you will then be stuck with a plumber's bill!)** If you use an old pair of rubber kitchen gloves the rubber will provide sufficient friction to loosen the collar.

Once the collar is off, the faceplate should come off easily. If someone has used plumber's putty or caulk to hold it in place you can carefully use a knife blade along the edge to loosen it.

4. Replace the faceplate and the collar
5. Replace the screw holding the handle on and the center cap.

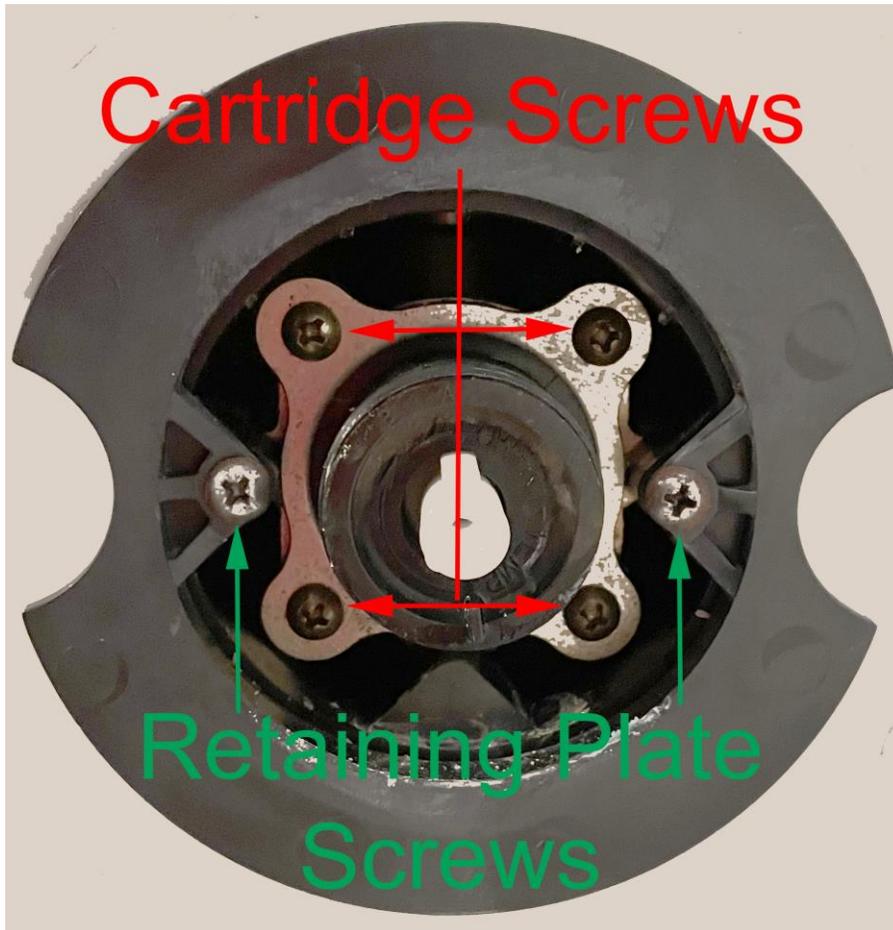
Valve Assembly Removal

Once the faceplate has been removed, you will see the valve cartridge and a retaining plate. The valve cartridge has four Phillips head screws holding it in place. The retaining plate has 2 Phillips head screws holding the mounting plate in place. **DO NOT remove the two screws holding the retaining plate as there is another ring assembly behind it that the valve sits in. If that second part falls into the wall, you are sunk! You will either need to call a plumber or cut a hole in the drywall behind the bathroom to retrieve the ring assembly.**

Before removing the screws, place a rag or paper towels under the valve to catch any water in the valve parts. Once the four corner screws are removed the valve cartridge will easily pull out of the valve housing along with the metal retaining plate in front of it. But you are not finished.

There is another part to the cartridge assembly behind the first unit! You can use your fingers (or needle-nosed pliers) to pull it out. This second part has two O-rings in the back of it. Check to make sure that **BOTH** O-rings are out. If one or both are still in the valve housing, use your finger to loosen and remove them.

1. Insert the Pressure Balancing Cartridge with the O-rings oriented properly and then the Valve Stem Assembly so that the protrusion is pointed in the correct direction.
2. Or, insert the one-piece cartridge so that the O-rings are oriented properly and the protrusion is pointed in the correct direction.
3. Insert the metal retaining plate and secure the 4 Phillips head screws.

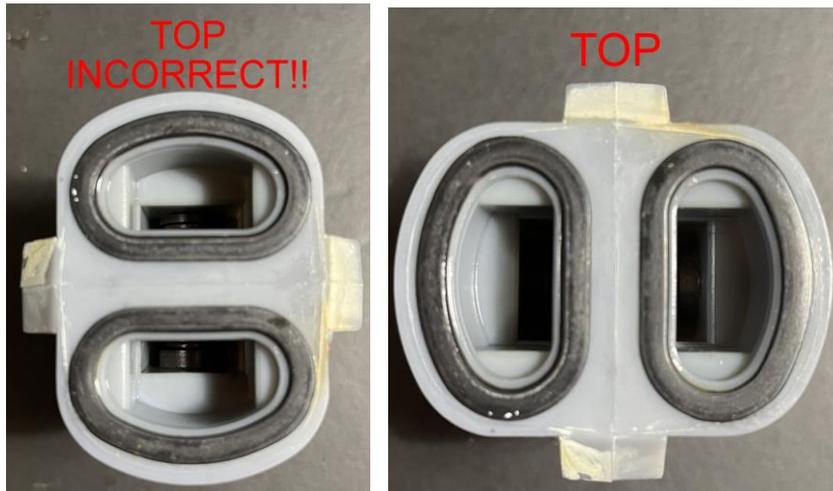
Make sure that you notice the orientation of the two O-ring seals when you remove this second part.

The correct orientation is shown in the right picture above.

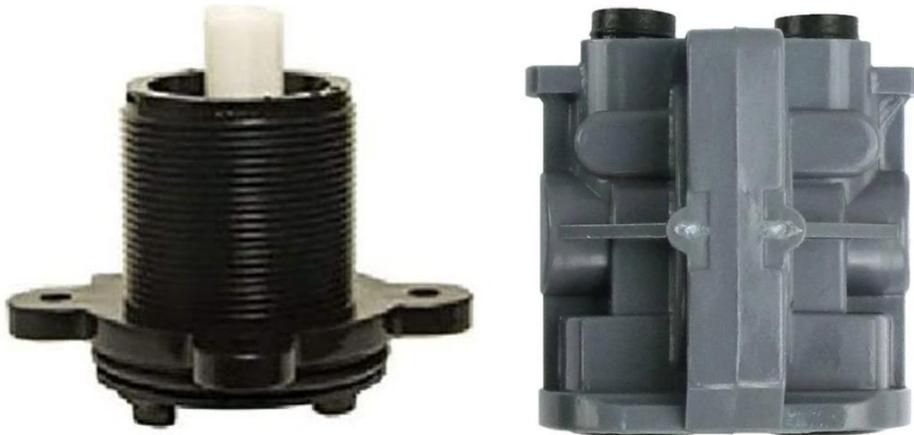
There are two different Price Pfister valves that look identical on the outward end.

These are the parts that come out of the shower and are the ones you need to do an exact replacement of the valve. Note that if the cartridge has been replaced previously, it may have the one-piece cartridge (see below).

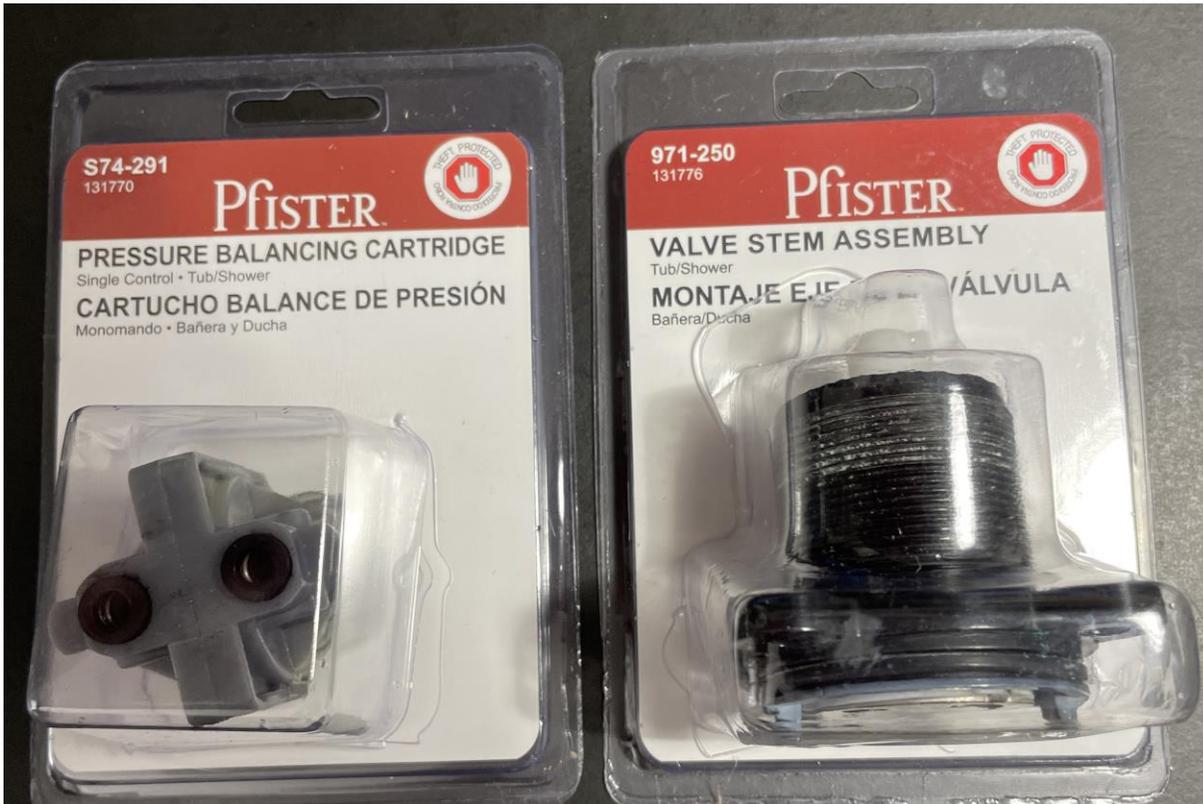
Two-Piece Cartridge

The parts to do an exact replacement of a two-piece cartridge are:

Pfister Valve Assembly – part number 971-250 (the front part); Cost = \$15 and change

Pfister Pressure Balancing Cartridge - part number S74-291; Cost = \$33 and change

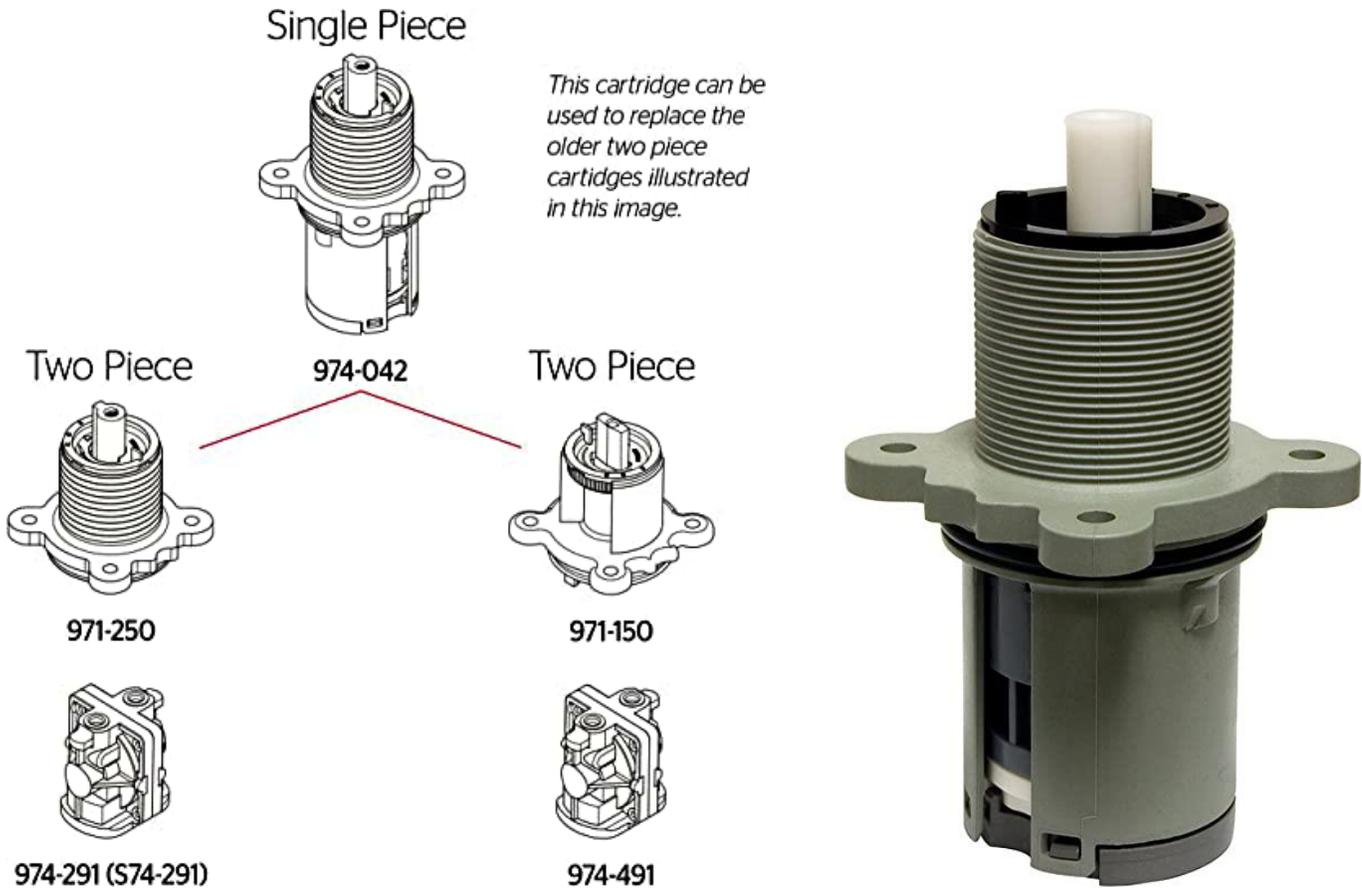
One-Piece Cartridge

According to Amazon.com, the page for Pfister part number 974-042 has the illustration on the left:

The illustration infers that the parts listed (on the left of the illustration) above can be replaced with Pfister Part #974-042 shown on the right.
